## FAILURE ANALYSIS REPORT

<b>DATE:</b> 6/29/2000	<b>CUSTOMER:</b> Internal	<b>NAME:</b> Vern Soldberg
<b>PART DESCRIPTION:</b> SIPAD board, TV46	<b>BATCH NUMBER:</b> N/A	<b>DATE CODE:</b> N/A
<b>JOB DESCRIPTION:</b> Examine solder joints after component placement onto an SIPAD board. The SIPAD board was previously equipped with non-conductive and tacky flux on the landing pads so no paste printing operation was necessary. Components were placed onto the adhesive flux and processed in a conventional reflow oven.

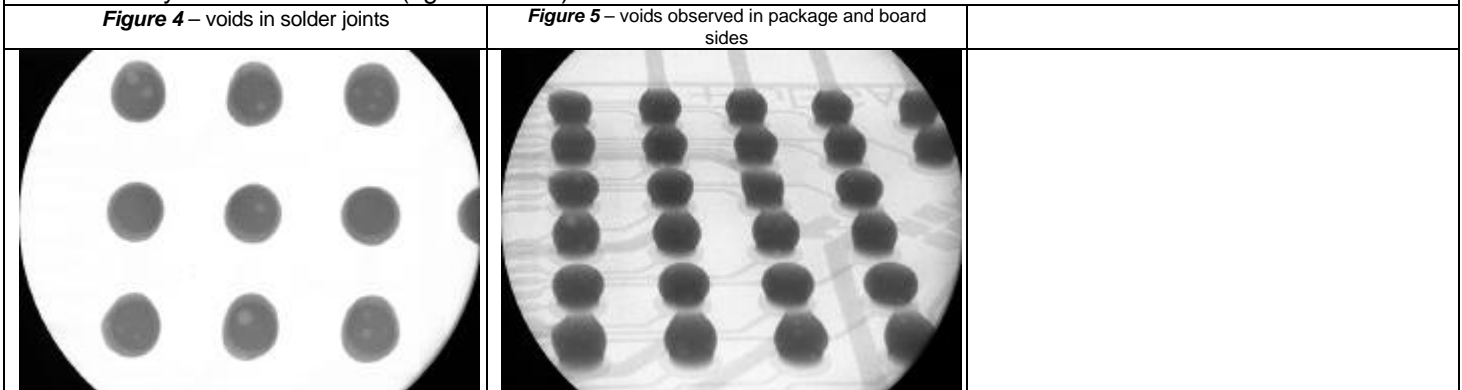
**X-RAY INSPECTION:**

Inspection using x-ray showed some voids in the solder joints. This suggests further optimization of reflow profile may be necessary to minimize voids (figures 4 & 5).

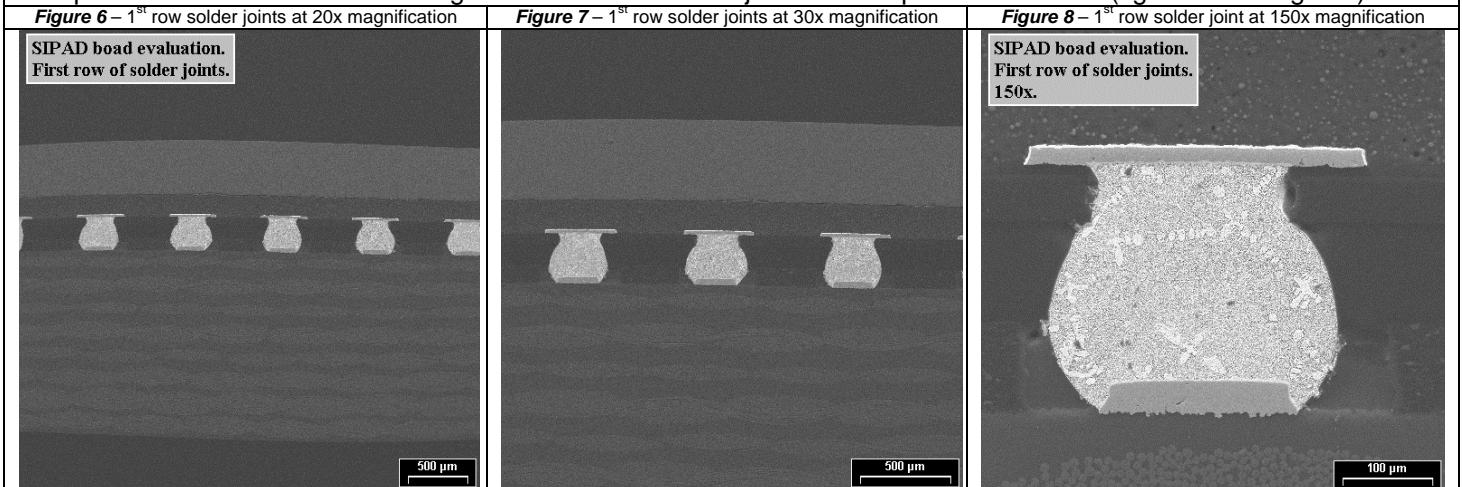
**CROSS-SECTION AND SEM:**

Samples were cross-sectioned through 1<sup>st</sup> two rows of solder joints and inspected with SEM (figures 6 through 11).

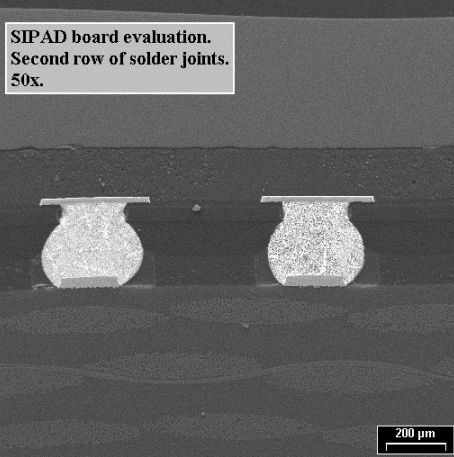
**Figure 9** – 2<sup>nd</sup> row solder joints at 50x magnification

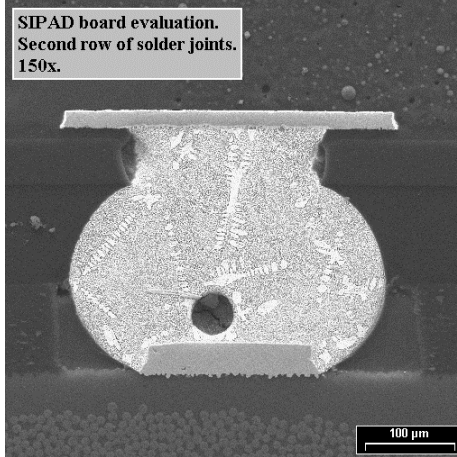
**Figure 10** – 2<sup>nd</sup> row solder joint at 150x magnification

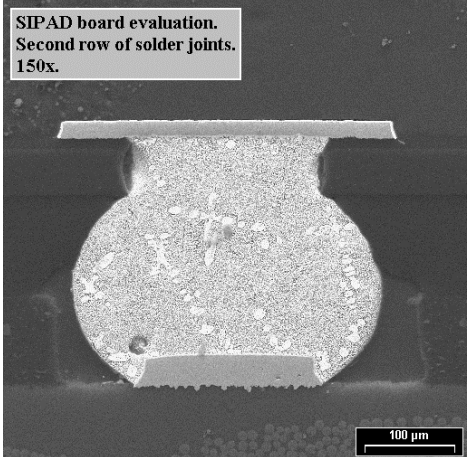
**Figure 11** – 2<sup>nd</sup> row solder joint at 150x magnification
